Special Inspection - BIBURY SWAN HOTEL - 97

Inspection Completed: 24-05-2024 By: Eden Wood

Three span stone arch on stone abutments and piers with spandrels and parapets. 17 T limit imposed in 1990. Span 1 1.29m headroom x 3m span. Span 2 1.4m headroom x 3.6m span. Span 3 1.2m headroom x 3m span.

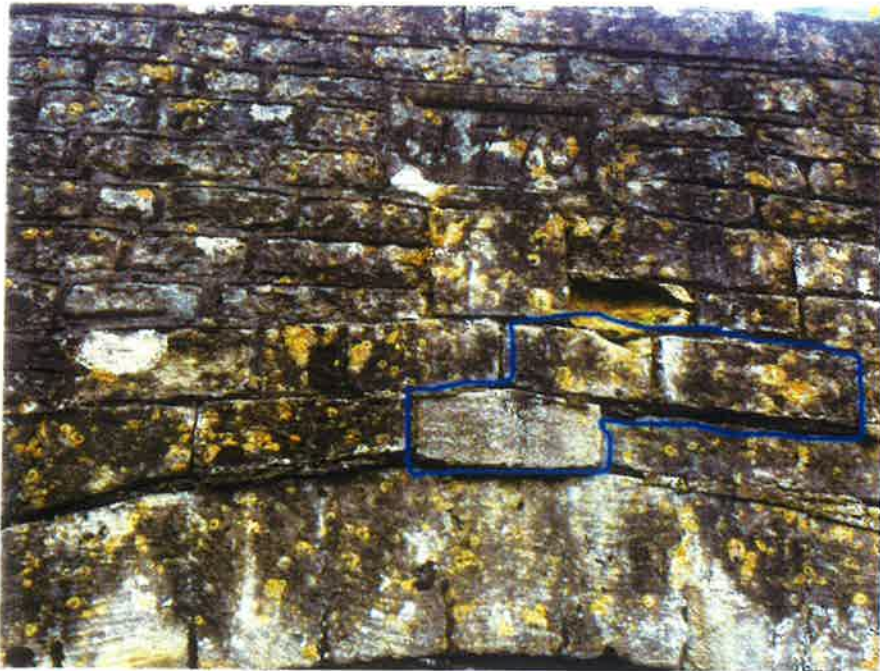
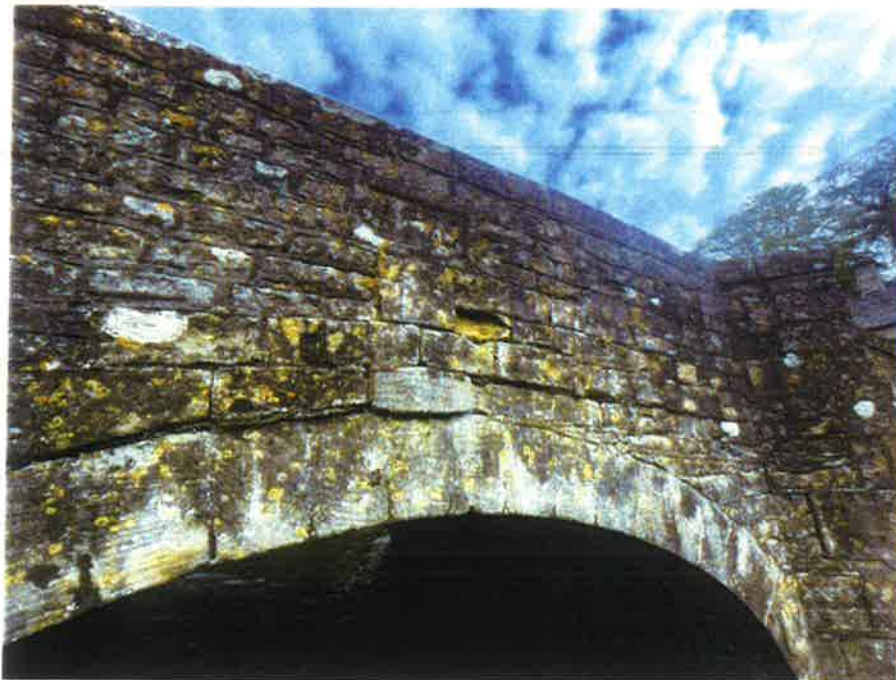
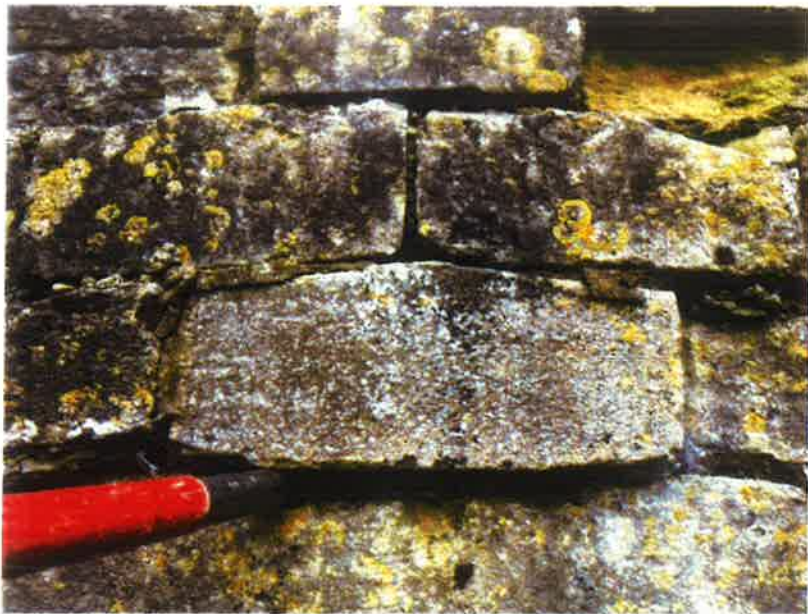
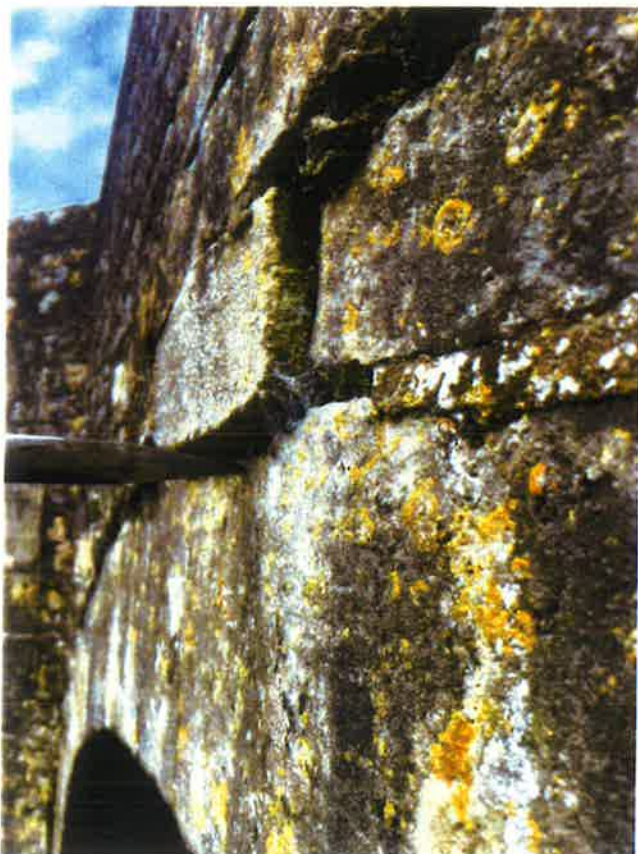
No.	Description	Est. Cost	Comments
10	Spandrel wall/head wall		<p>Area of calcite staining on the upstream spandrel stonework. Three stones identified that have moved since previous inspection in Nov 2023. Stone directly above the arch on the downstream end has moved significantly, is loose and missing pointing below. Compared to previous GI in Nov 2023 the stone has moved approx. 50mm. The other two stones have less movement but clearly visible movement when compared with GI from Nov 2023.</p> <p>GI - Nov 2023 - Minor displacement in the downstream spandrel and east pilaster causing cracking, bulging and leaning. There are no apparent signs of any impact to the parapet which may have caused it. Displaced areas need to rebuilt. Minor pointing loss in the stonework on the upstream and downstream spandrels</p>

Take down and rebuild the section of the parapet/spandrel wall. The masonry should be reset and repointed during the reconstruction. The specific section to be rebuilt is estimated to be 2.5m in total although this will be determined as part of the design.
